## PART 21 REPORT - FUEL INJECTORS FAILED PRESSURE TEST

**Report No. 10CFR21-0109**

**10CFR21 REPORTING OF DEFECTS  
AND NON-COMPLIANCE**

**COMPONENT:** EMD Fuel Injectors  
P/N 40084720 & 40099335

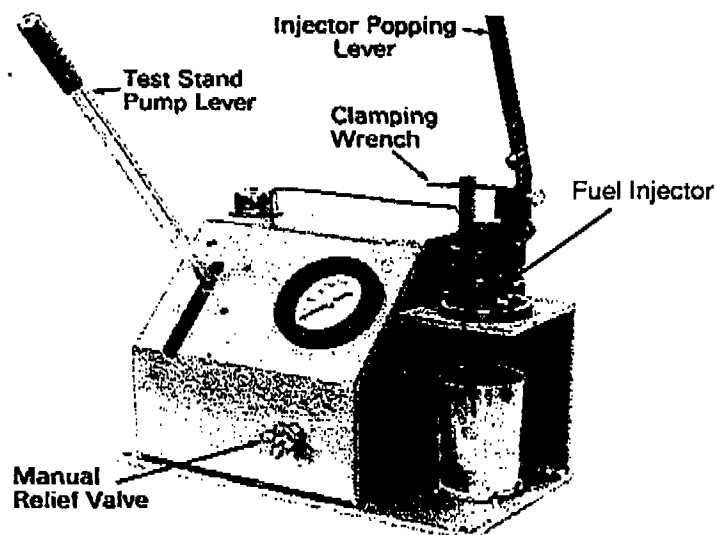
Figure 1: EMD Fuel Injector Tester

The standard holding pressure and leakage test specified for the EMD fuel injectors requires applying 2000 psi to the fuel injector and verifying the pressure does not fall below 1500 psi after 30 seconds. This test is performed on an Injector Tester designed specifically for this purpose. See Figure 1 below.

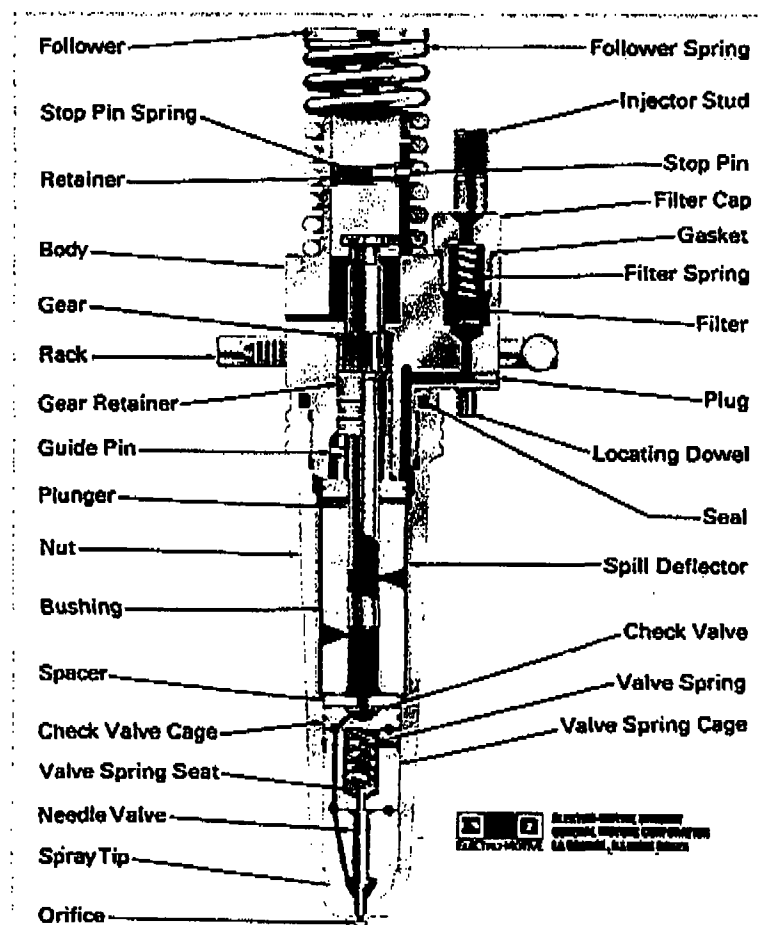
.. Cut-away of EMD Fuel Injector

- TVA injectors (S/N 12K20318, 12K20385, & S/N 12K20330)
  - Non-metallic material was found along the plunger/bushing, spacer, check valve cage, valve spring cage, and the nozzle. The material was very small and difficult to see by the naked eye. Using a video microscope, the material was identified as small strands of fiber similar to nylon string. In some instances, the material was so small that it would disintegrate when moved around. A larger piece was found within injector s/n 12K20385, located in the nozzle oil passage.

- TVA injector (S/N 11K23136)
  - This injector only had one trace strand of non-metallic material on the outside of the bushing. Unlike the other TVA injectors above, no material was found along the plunger/bushing, spacer, check valve cage, valve spring cage, or nozzle.

- Davis-Besse injector (S/N 12H23003)
  - Metallic material was found between the nozzle and the spring body cage and at the interior of the nozzle. The debris found in the nozzle was flattened at one end, indicating it was trapped between the nozzle tip and the needle valve preventing the needle valve from achieving a proper seal.

- Non-nuclear customer injectors (S/N 12K20404 & 13A23943)
  - Metallic material was found in both of the fuel injectors. The material was a very small strand of wire that resembled the wire mesh of the injector filter elements. Parts of the wire were also flattened indicating that it was compressed between two surfaces, i.e. the needle valve and nozzle tip, which would prevent the needle valve from seating. S/N 13A23943 also contained a small piece of metallic material that resembled casting flash.

It has been determined that the debris entered the fuel injectors during assembly of the filter elements into the injector body at the manufacturer. Inspection of the filter element storage container revealed an excess of metallic and nonmetallic contaminants. The metallic material resembled the wire like material found in the injector nozzles; this was determined to be pieces of the injector filter material (0.004" diameter wire). There was also nonmetallic material present in the container as well; this is suspected to originate from packaging materials.

- The fuel injector manufacturer has implemented a work instruction to ensure cleanliness of the filter elements and the corresponding container in which the elements are placed prior to being issued for insertion into the fuel injector. This container will also be labeled to indicate that it has been through the cleanliness process.
- ESI will add an additional injector pressure test requirement for all EMD fuel injectors supplied on nuclear safety related sales orders. The additional test will be performed by ESI after calibration/performance testing is completed. This will be implemented for new and rebuilt fuel injectors as an additional verification of injector performance/operability prior to shipment to the customer.
